**Slew gear mounting bolts**

| <b>Product:</b> | Maxilift | <b>Document No.</b> | TB-027-A |

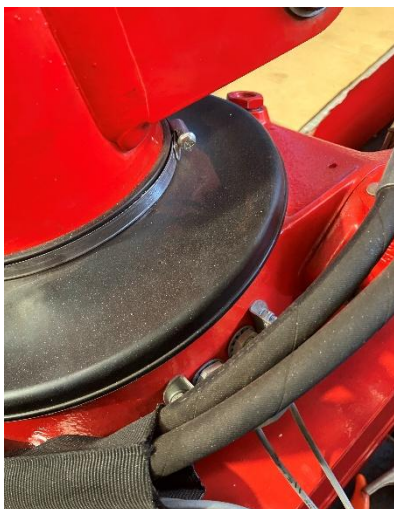
PIC 1

It has come to our attention that its quite common to find the slew gear mounting bolts lose at service, resulting in damaged threads in the slew gear and the shearing of the bolts (as seen below). It is our recommendation that all slew gear bolts are to be checked at every service.

1. have crane in a secure and safe position.
2. remove rubber boot. Pic 1
3. remove one bolt at a time to prevent dis-enlightenment of slew gear.
4. inspect bolt for thread damage. Pic 2
5. inspect slew gear thread.
6. re-install bolt with Loctite and tighten accordingly .
7. carry out steps 3-6 until all bolts have been checked and torqued.
8. refit rubber boot.
9. check operation of slew gear.
